WILSON'S OIL HOUSE, LARD REFINERY,
AND EDIBLE FATS FACTORY
2801 S.W. 15th Street
Oklahoma City
Oklahoma County
Oklahoma

HAER No. OK-4

WRITTEN HISTORICAL AND DESCRIPTIVE DATA

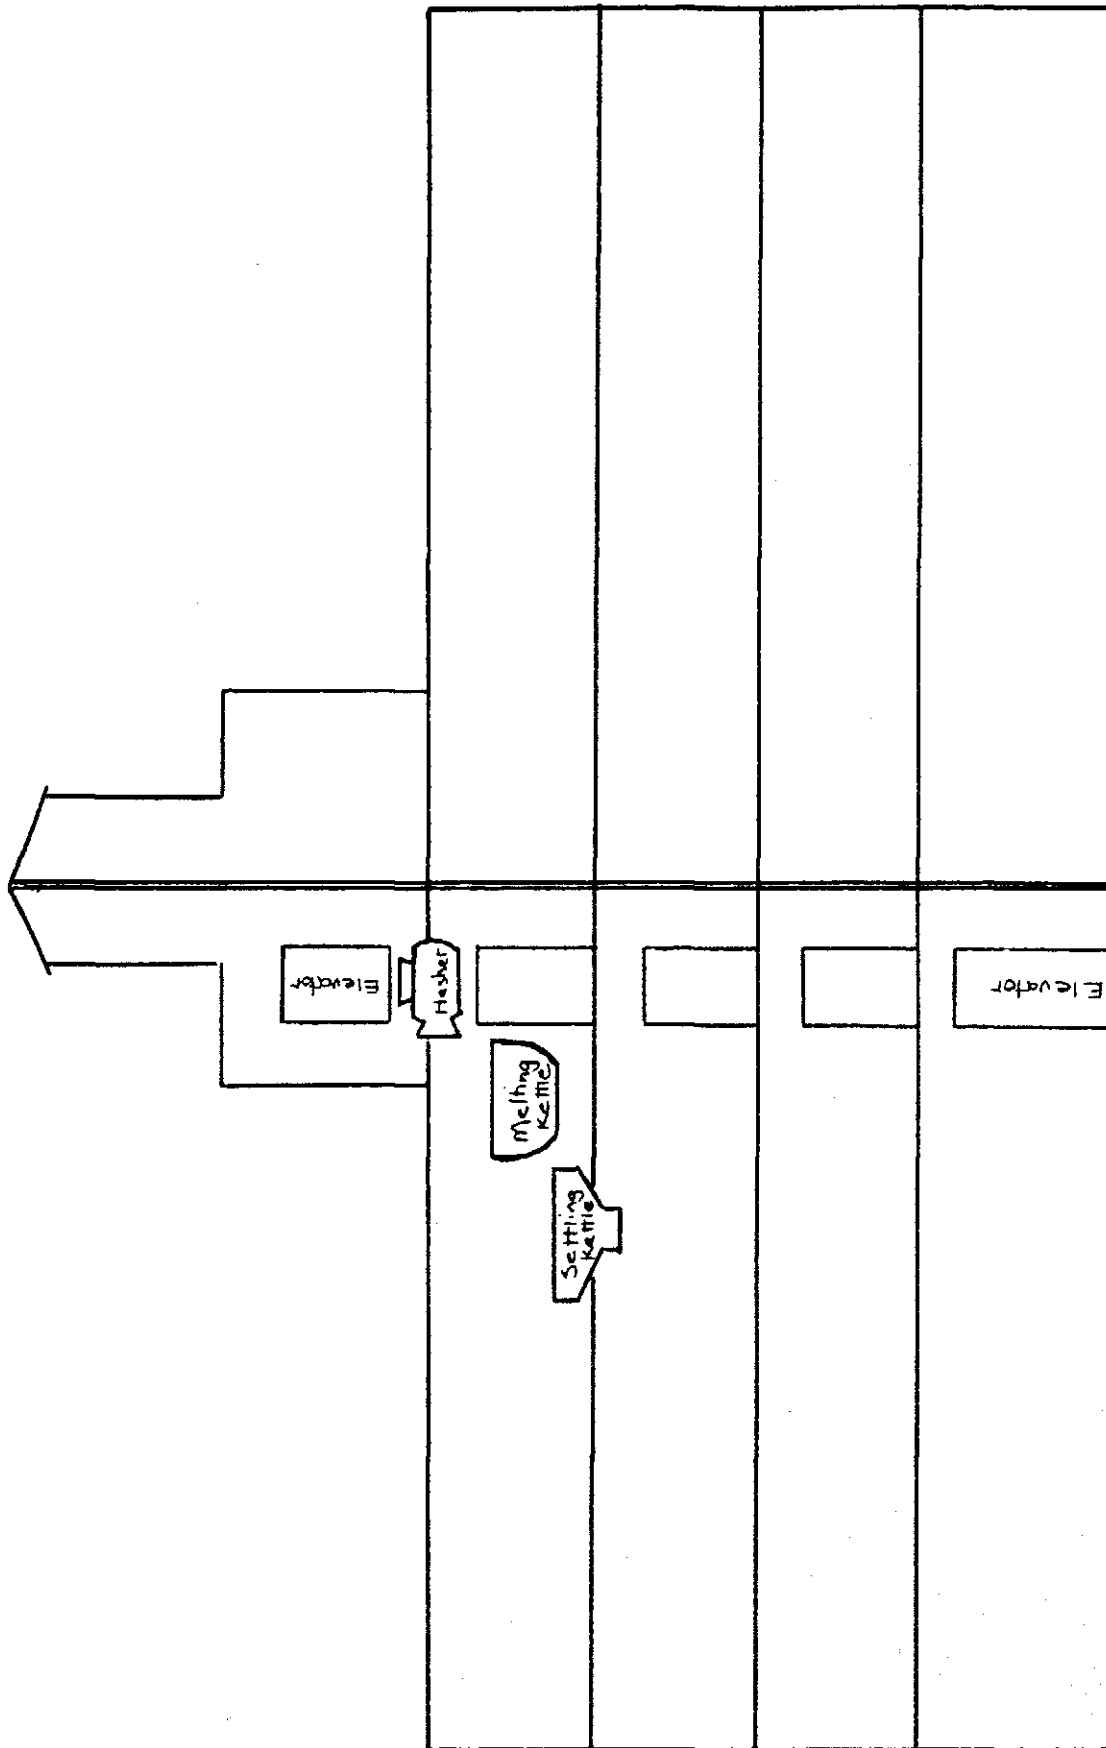
This sketch is a cut-away of the south side of the Oil House (left side of the firewall) and the Lard Refinery (right). Based on the only set of blue prints and specifications from the 1911 construction, this sketch illustrates how fatty meat products were lifted via elevator to the half-story of the Oil House, then put through the hasher, dumped into the melting kettle, and deposited into the settling kettle. Apparently the rest of the procedure included pressing through cloth to remove more impurities and the final packaging. Not until the 1930s did the plant implement hydrogenization or deodorization.

1. Floor Plans: All floors of the buildings were originally wide open, interrupted only by a firewall that separated the Oil House (bldg. 8) from the Lard Refinery (bldg. 9). Along the central bays on either side of the fire wall were elevators which would lift raw materials (tallow and lard) to the hasher and melting vats located on the top floors. Otherwise, all floor space was used for various stages of the refining, packaging, and storage processes.
